# PdMA Case Study – Mining Drill Motor

## CASE STUDY #1 DETECTING BROKEN ROTOR BAR

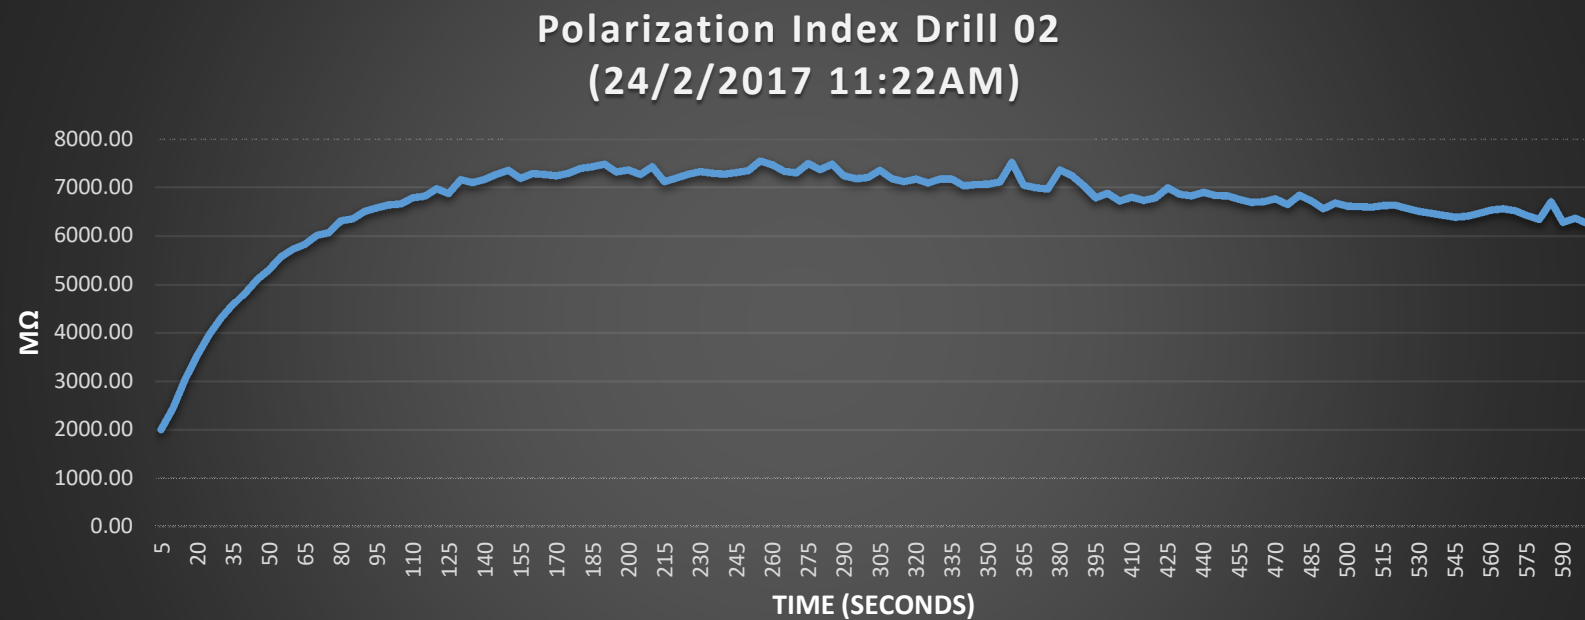
## Polarization Index Graph

*Insulation resistance to ground was good, however the polarization index was low at 1.092. A healthy stator should have a PI of at least 2.0*

*The PI graph indicated that there was some kind of moisture or contamination present in the stator winding*

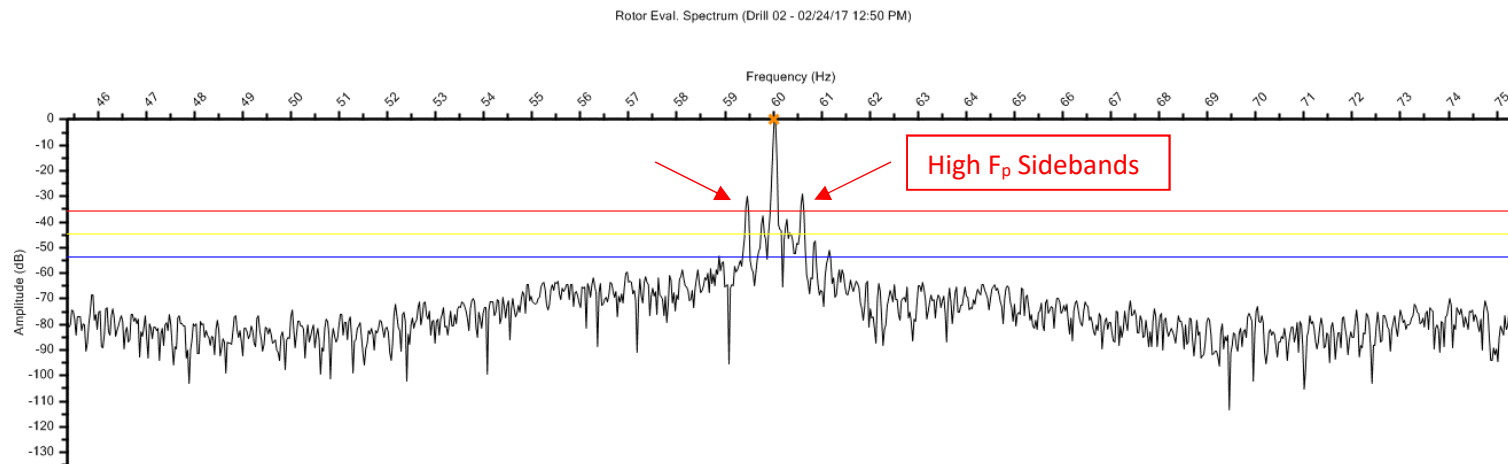
## Rotor Evaluation

*Rotor Evaluation Spectrum showed high pole pass frequency sidebands around line frequency. This indicated rotor bar defects were present*

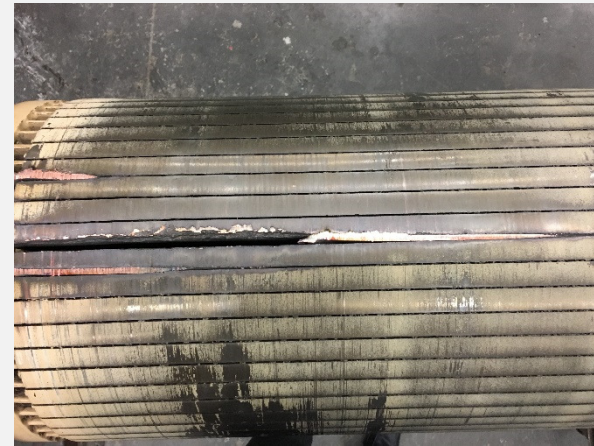
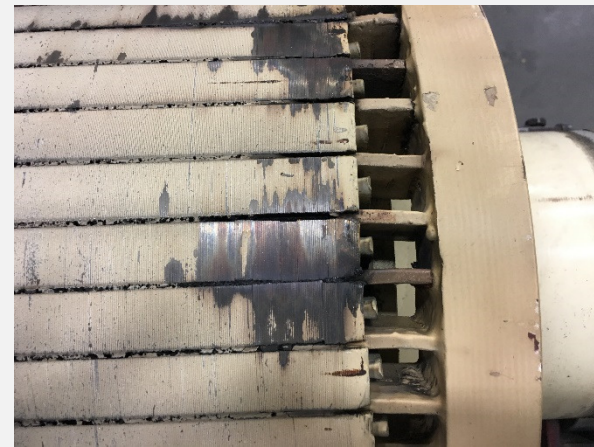
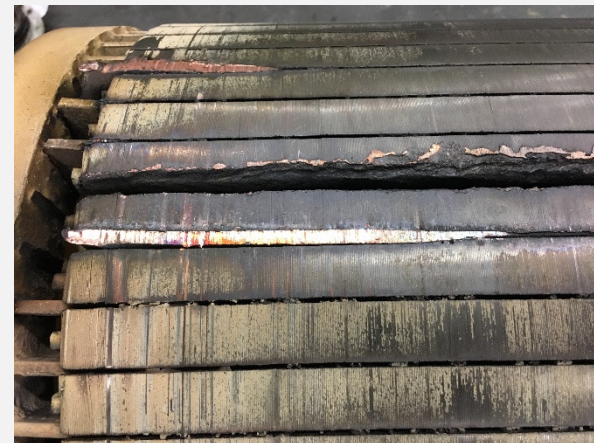
*After the motor was sent to Armature Electric and dismantled, the rotor bar damage was evident.*

*2 rotor bars were melted, and many more had twisted at the slot exit where the bars joined the end rings.*

*This motor had experienced many full load, across the line starts*

*The rotor required a completely new lamination stack and re-bar.*

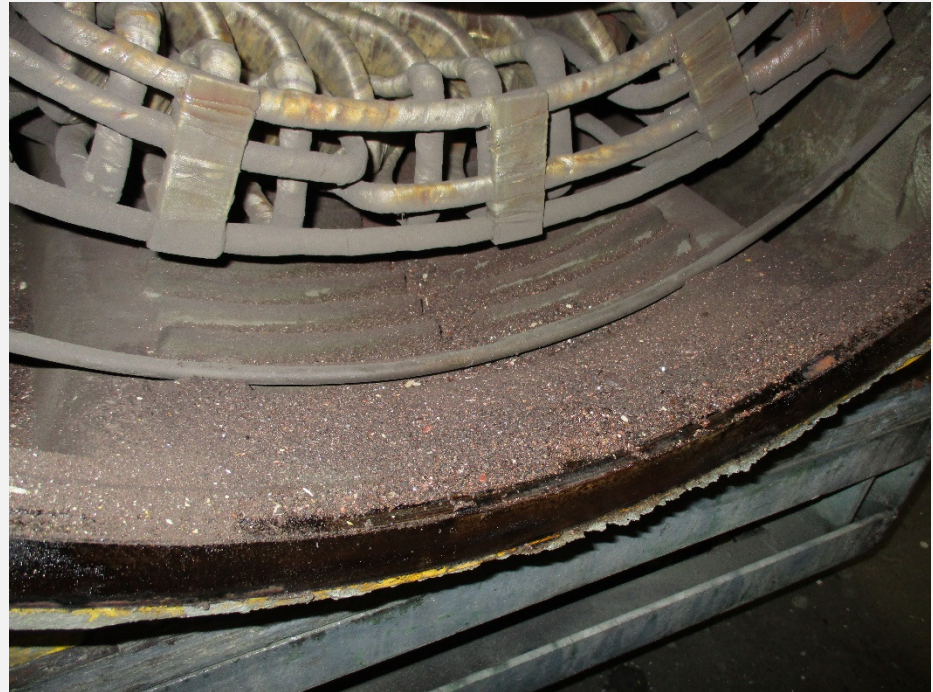
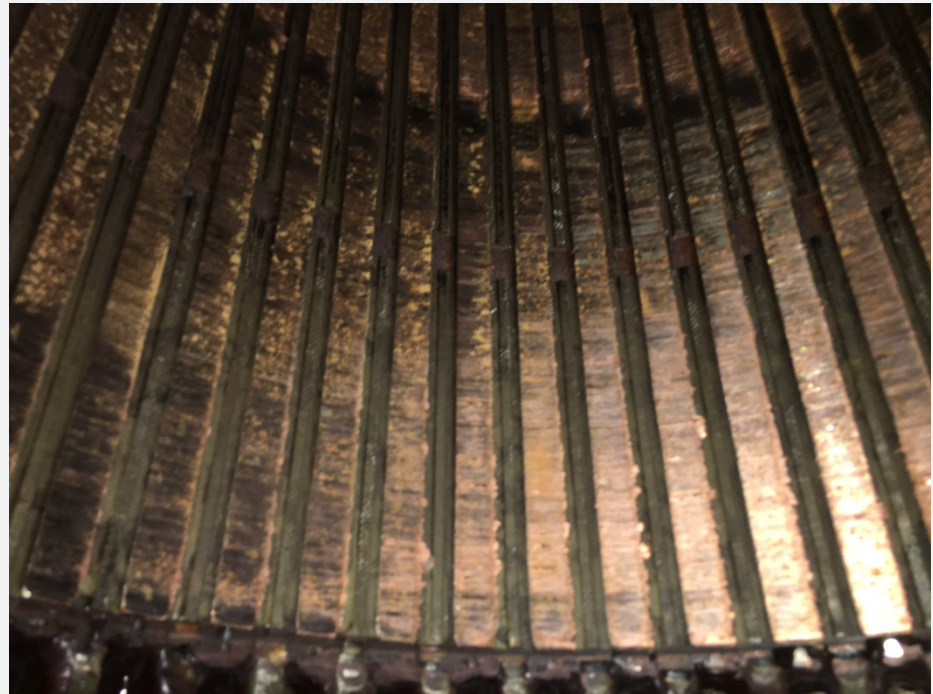
## Stator

*The cause of the  
low PI?*

- *Copper dust  
from the  
blown rotor  
bars*
- *Copper  
embedded to  
the stator  
slots*

*After the stator was washed, baked and the embedded copper removed, the Polarization Index greatly improved*

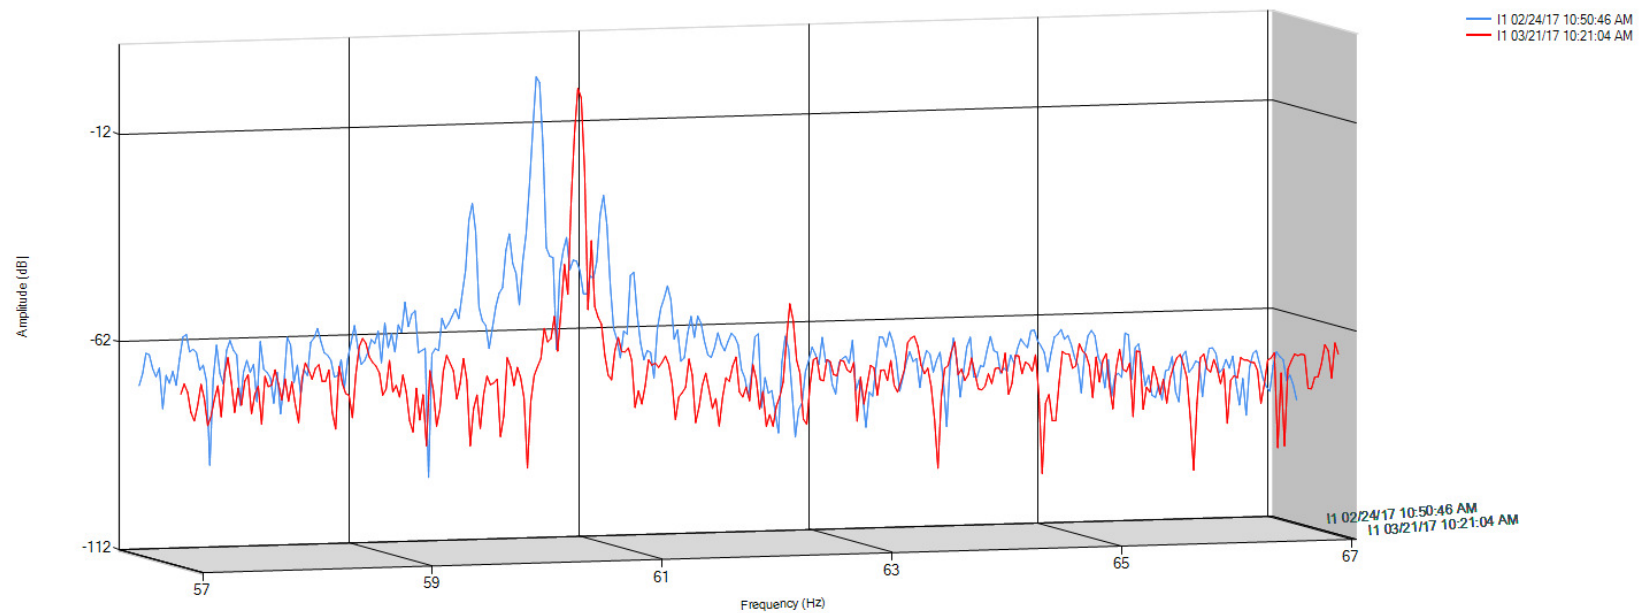
## Rotor Evaluation After Repair

*With the newly laminated and re-barred rotor, another rotor evaluation was performed. Note the  $F_p$  sidebands have disappeared*
