# PdMA Case Study – Mining Drill Motor

## CASE STUDY #1 DETECTING BROKEN ROTOR BAR

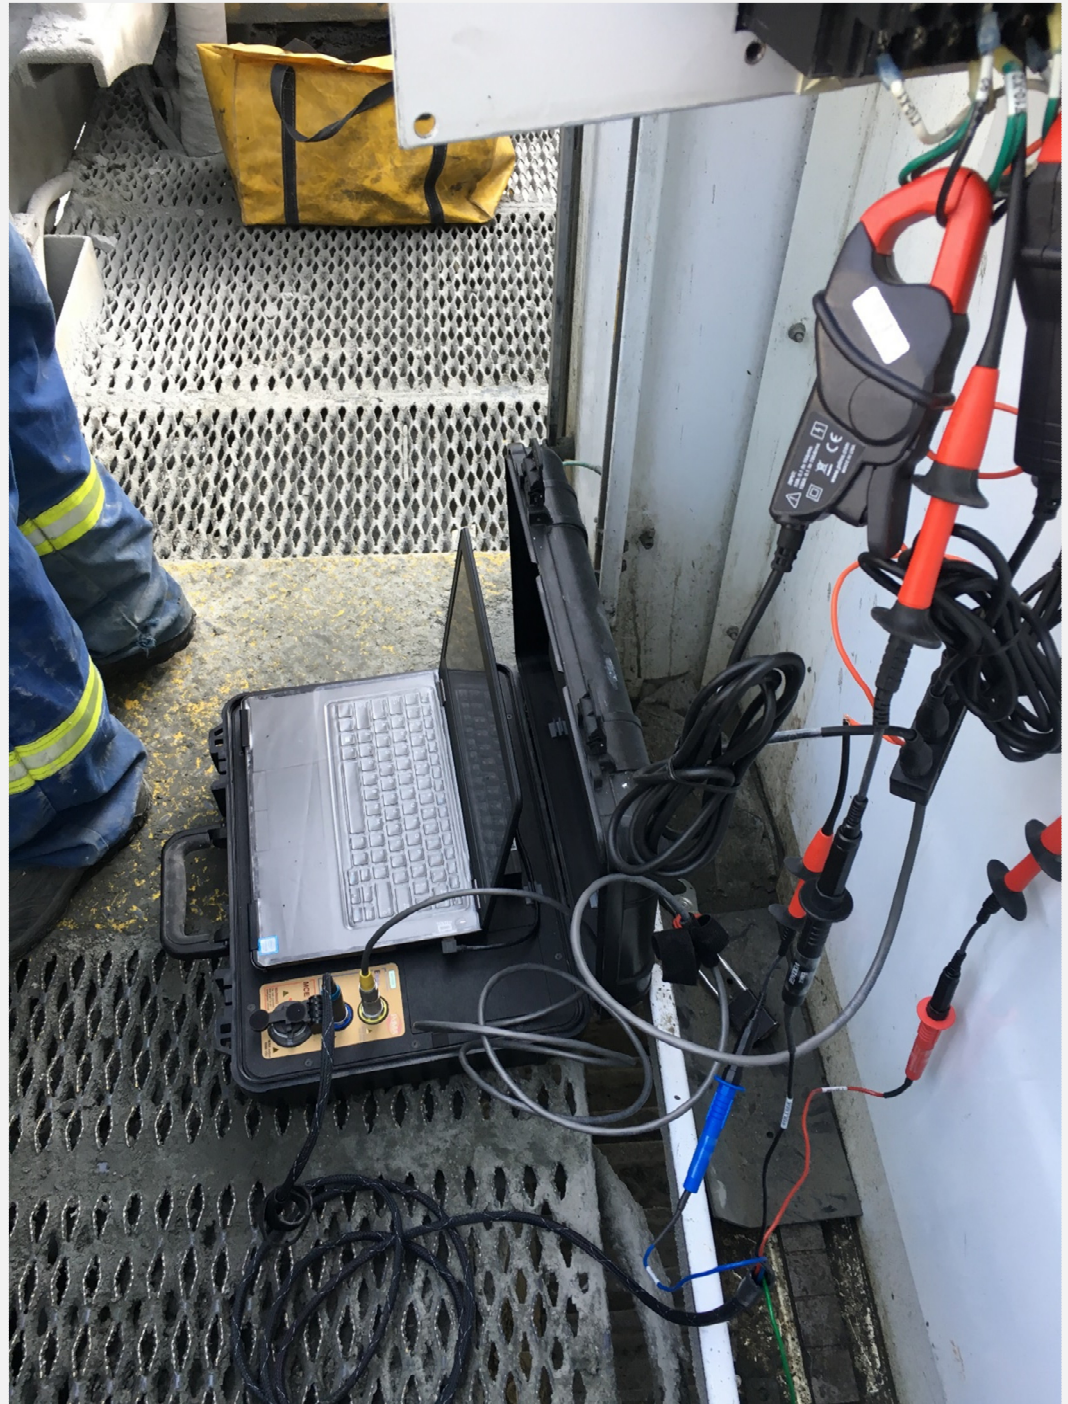
## Test Procedure

*Drill motor was locked out and isolated from power supply*

*MCEMax test equipment was set up*

*Static motor tests were performed with the test machine connected to the motor T-Leads that were disconnected from the soft starter*

*Dynamic motor tests were performed with the test machine connected to the Multilin Protection Relay*
